**CULTURAL HERITAGE DETAILS**

**Cultural Heritage Evaluation Report &  
Heritage Impact Assessment  
Bruce Road 3 Bridge (Queen Street Bridge)  
Paisley, Arran-Elderslie, Bruce County, ON**

**Report Draft: May 2020, Revised October 2021**

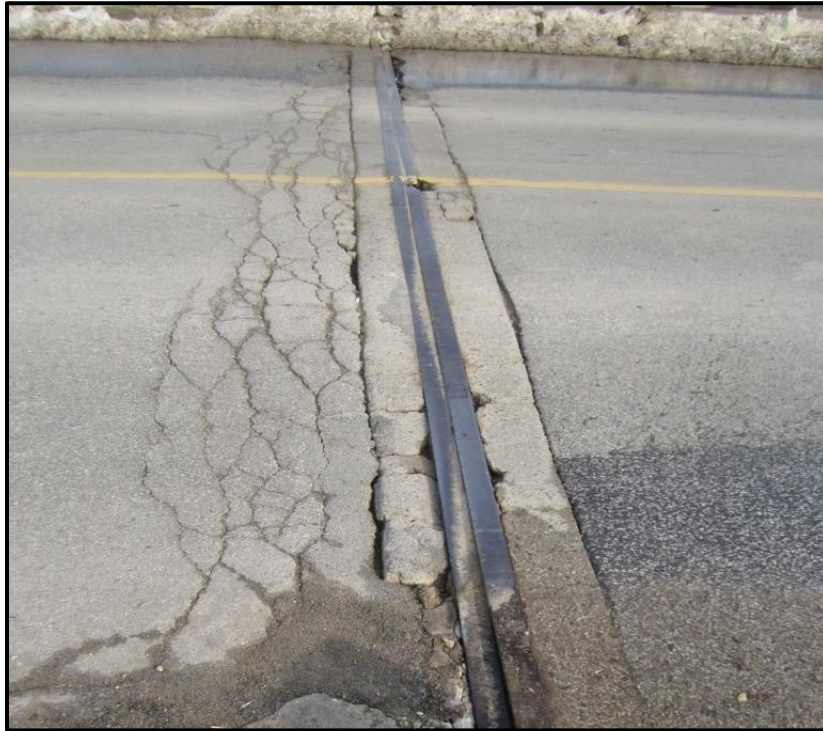
The edges of the curved concrete T- beams show spalling and exposed steel re-enforcing rods in the concrete. The underside of the deck shows significant spalling exposing the steel re-enforcing rod within the concrete (Image 8). Expansion joints are located on the deck surface and also exhibit significant deterioration (Image 7).

**Image 7: Close up of Expansion Joint Deterioration (Courtesy B.M. Ross & Associates)**

A 2016 Inspection Report for the bridge indicated that a number of repairs were required within the next five years: patch repairs on the north abutment face and replacement of the ballast wall; replacement of expansion joint assemblies at both ends of the bridge; patch repair of spalls at the middle span of the girders/beams; patch repair of sidewalks; refacing of concrete at the north wingwall; patch repair of sidewalk cantilevers and edge beams of the soffit/deck; and replacement of south ballast wall and storm drainage.<sup>45</sup>

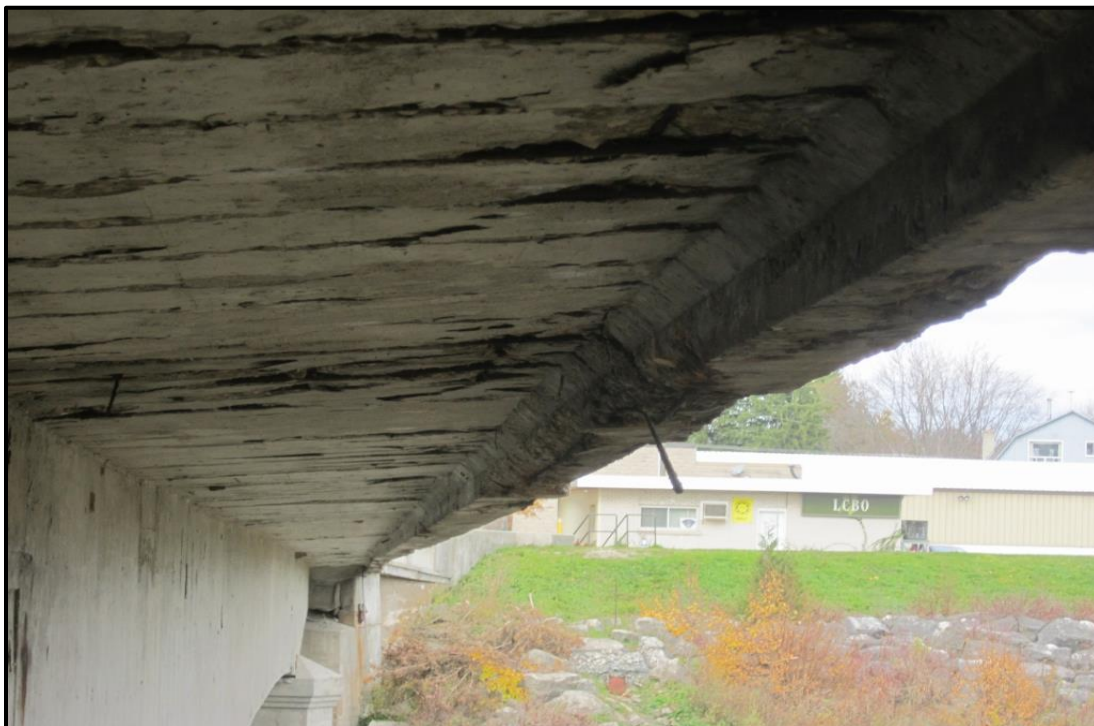
**Image 8: Close up of Underside of the Deck (Courtesy B.M. Ross & Associates)**

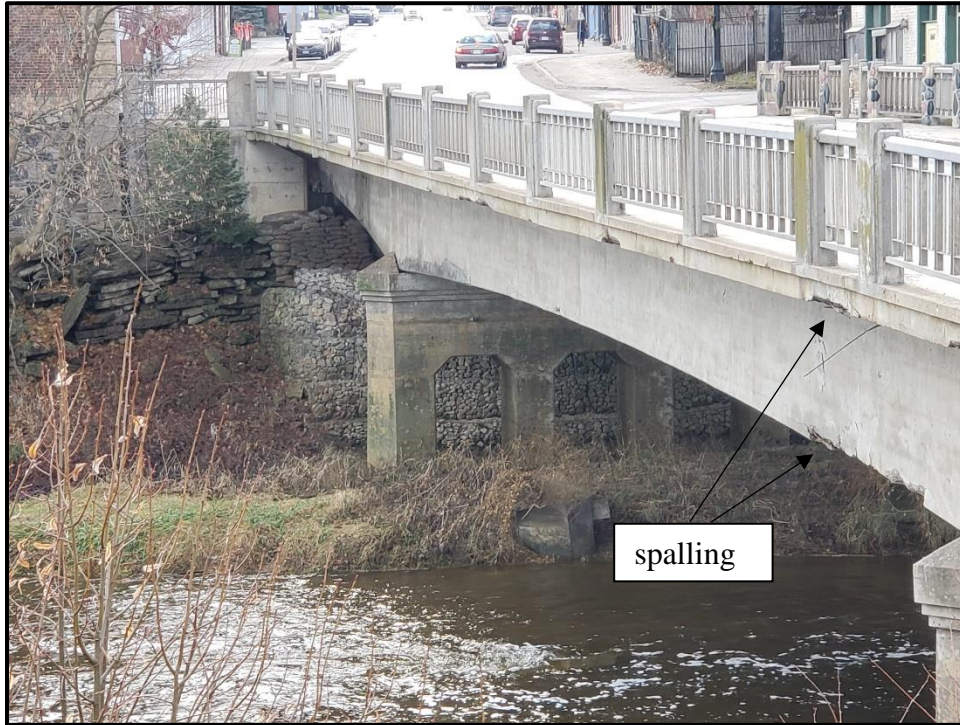
**Image 9: South abutment of Bruce Road 3 Bridge (TMHC 2019)**

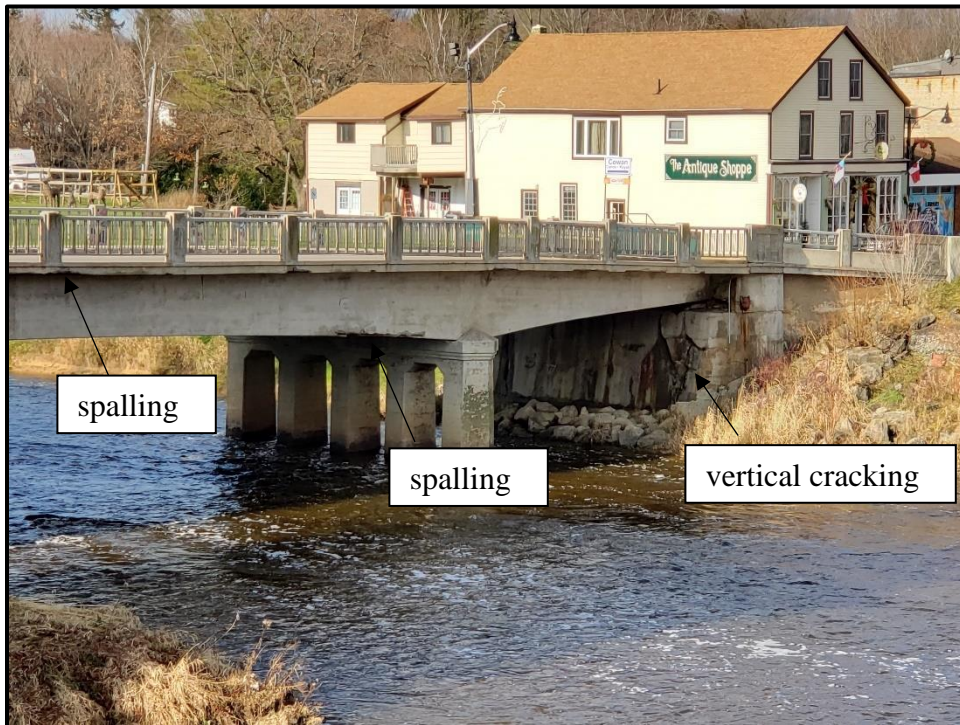
The lower portion of the Bruce Road 3 Bridge consists of concrete abutments and piers. The piers are located at the end of the reinforced concrete central curved span. Partial curved T-beam spans are present at the north and south end of the bridge extending from the pier to the concrete abutment built into the north and south banks of the river. The abutment on the south bank is connected to the former mill race (Image 9). Concrete can be seen spalled off from the surface of the abutments. The northwest abutment has a significant crack extending down from the top (Image 10).

**Image 10: North Abutment of Bruce Road 3 (TMHC 2019)**

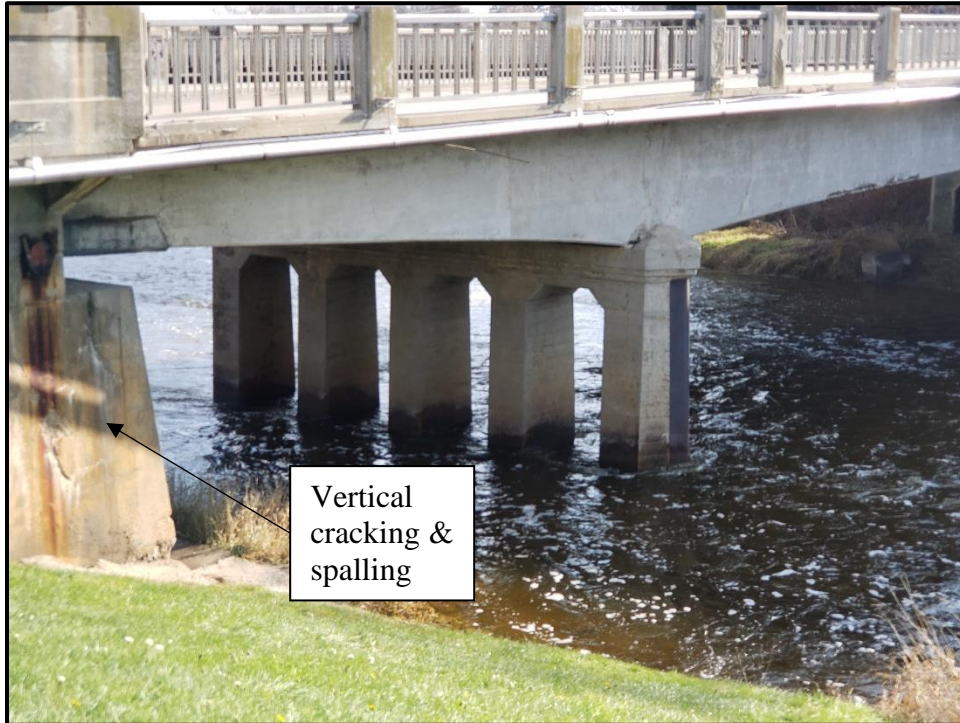
**Image 13: Southeastward view, north supports of Bruce Road 3 Bridge (TMHC 2019)**

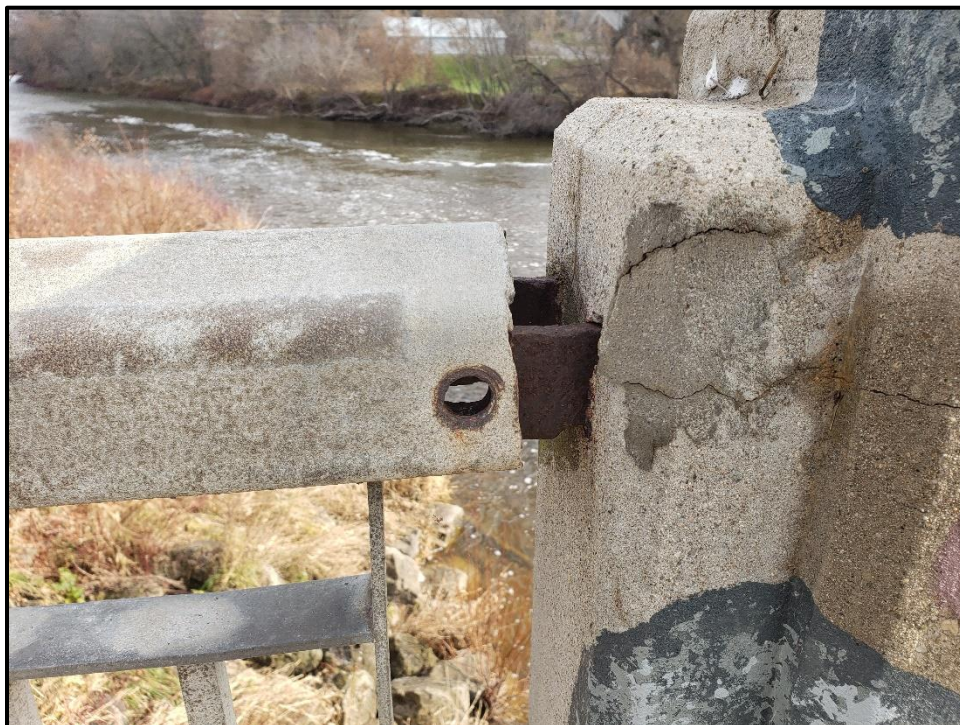
The upper portion of the Bridge consists of curved concrete T-Beams, a concrete deck with an asphalt surface on the travelled portion, concrete sidewalks on both sides of the bridge with a concrete curb separating the sidewalk from the travelled portion of the road, and metal railing sections attached to regularly spaced concrete posts located along the east and west side of the deck. The concrete posts are also spalling with some repair having been previously attempted. Some of the posts are also cracked horizontally at the base where they connect to the deck (Image 16 and 17).

**Image 16: Railing condition at northeast portion of Bruce Road 3 Bridge  
(TMHC 2019)**

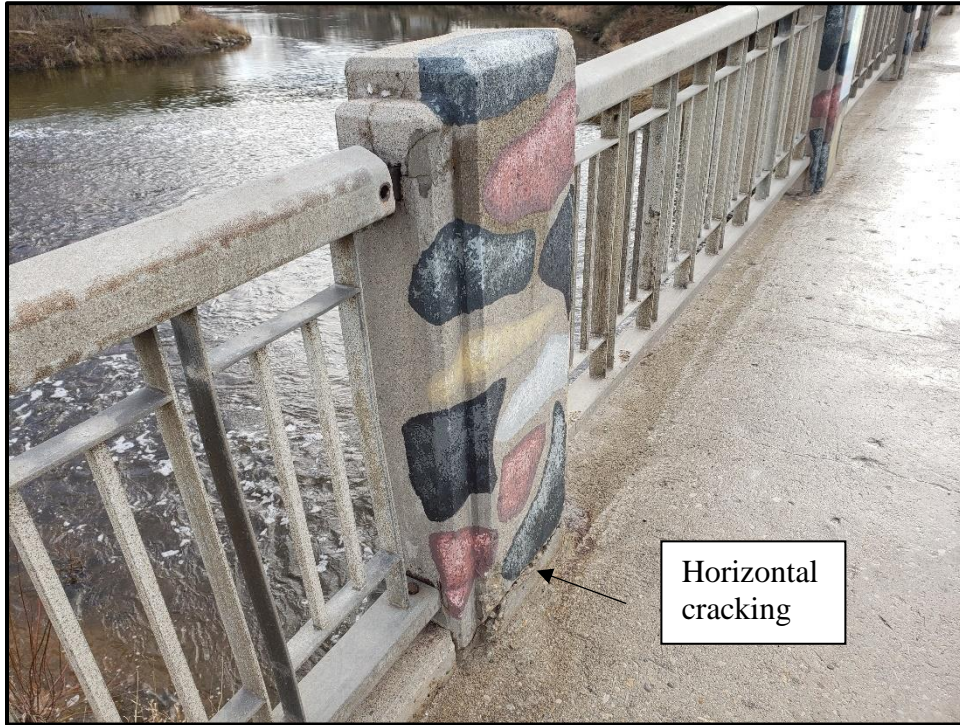
**Image 17: Close up of Pillar with Crack at the Base (TMHC 2019)**

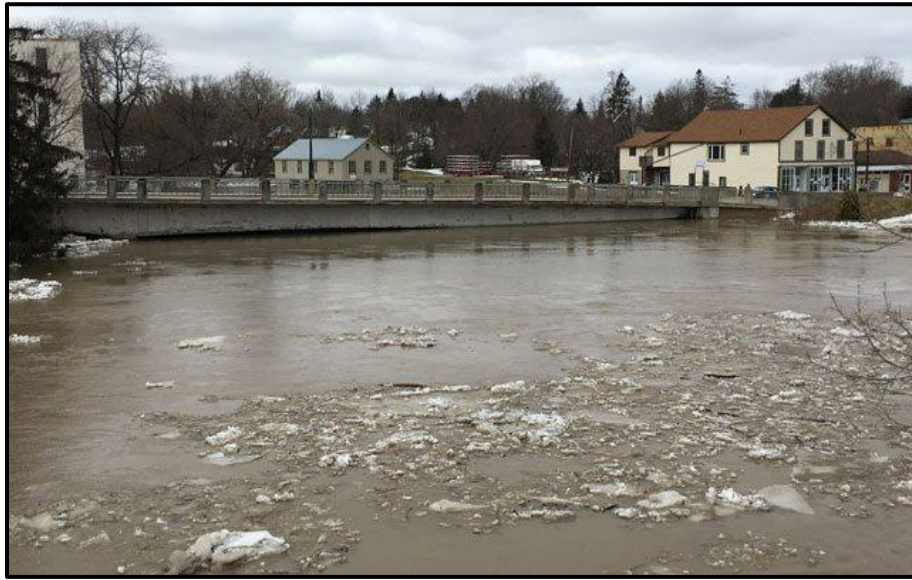
The Bruce Road 3 Bridge is proposed for replacement in 2022 due to deterioration of the current bridge and concerns about its capacity to withstand high-flow events. Flooding of the Teeswater River in February 2018, for example, resulted in road closures and heightened worries about the bridge's ongoing structural integrity.<sup>48</sup> The bridge replacement will allow for continued infrastructural functionality in this location.

**Image 23: Water levels at the Subject Site during a high-flow event in 2018**  
(Blackburn News)
